# Inspecting Covered Bridges

Best Practices for Inspection,  
Condition Assessment, and  
Repair Recommendations

# Indiana Bridge 70-00094B

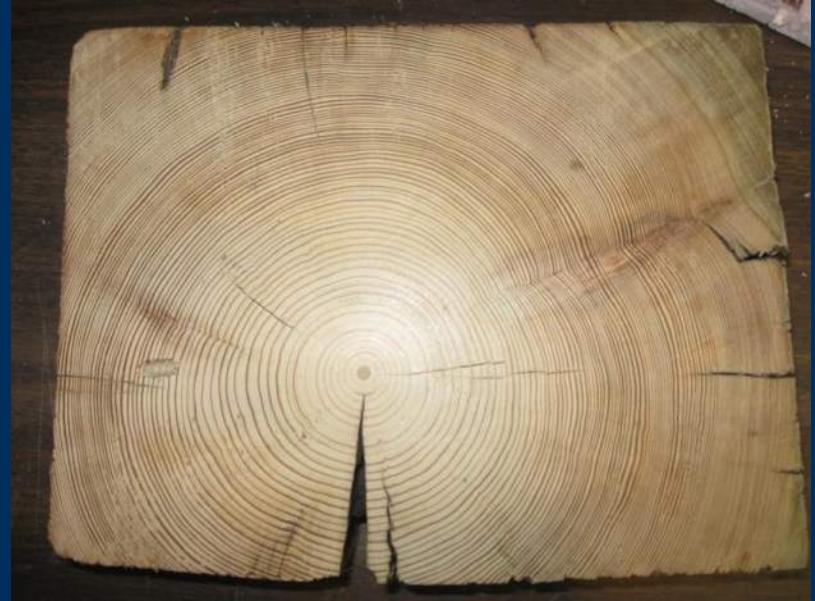
# Solid Sawn Timber

- **Beams and Stringers**
  - Pieces 5 inches and thicker, rectangular width more than 2 inches greater than the thickness
- **Posts and Stringer**
  - 5x5 and larger with width not more than 2 inches greater than the thickness

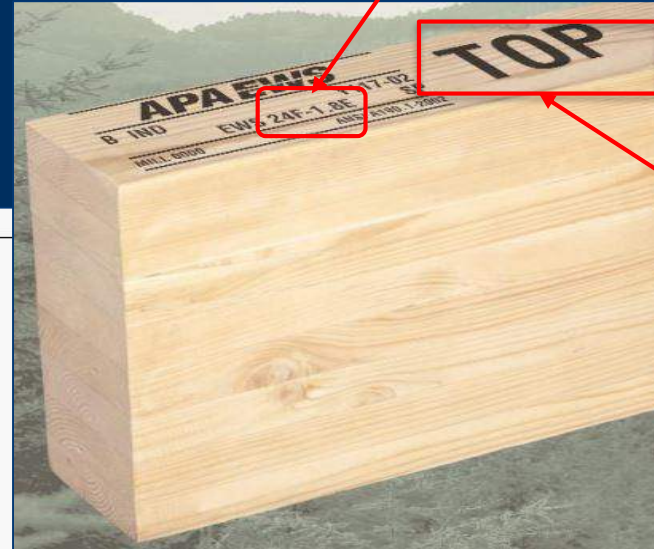
The glulam grade defines the layup for the beam and the allowable stresses

Top of beam identified for unbalanced layups

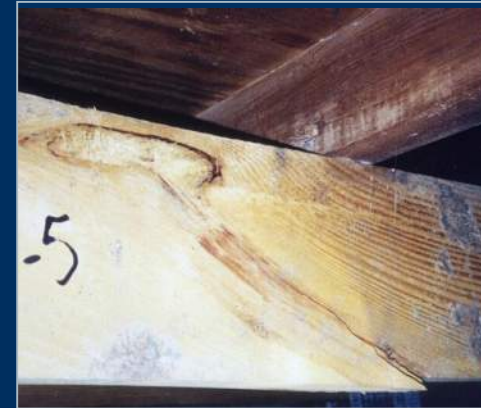
Select Structural:	1:12 (1:15 at middle 1/3)
No.1 Grade:	1:8 (1:12 at middle 1/3)
No. 2 Grade:	1:6

Poor slope of grain

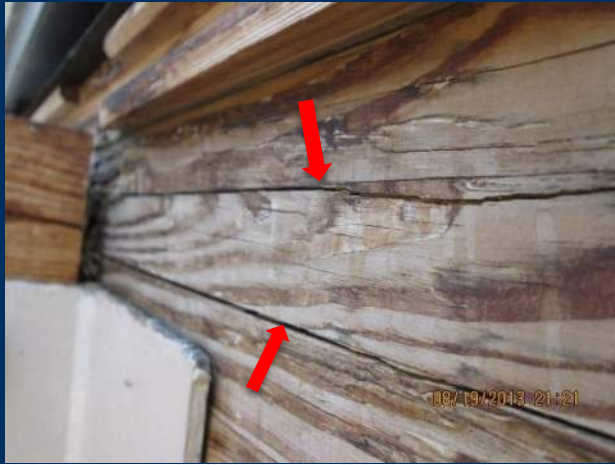
- Checking is possible for glulam members if the moisture content increases and then subsequently dries in an uncontrolled manner.
- Checks that occur in glulam members are usually located at the glue joints (see AITC Tech Note 11)
- These checks can be mistaken for glue line failures.
- Inspect the interior of the check and measure the depth to confirm. (See also AITC Tech Note 18)

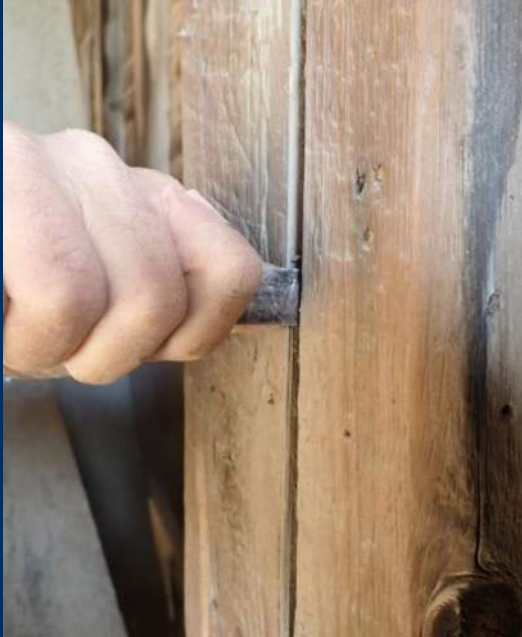
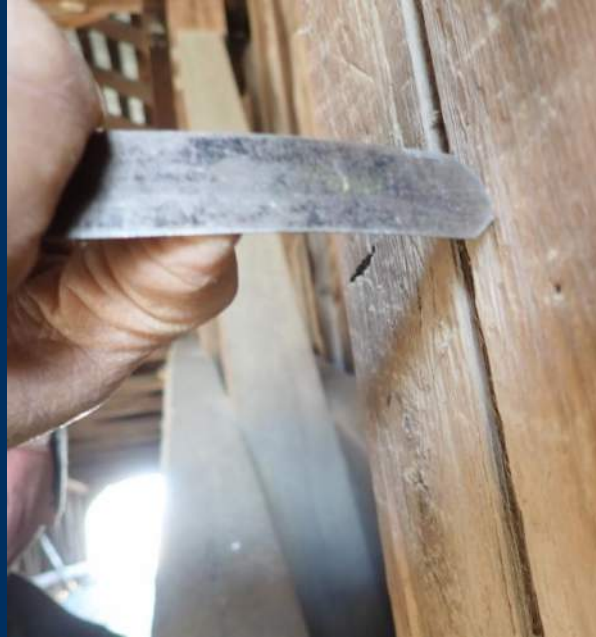
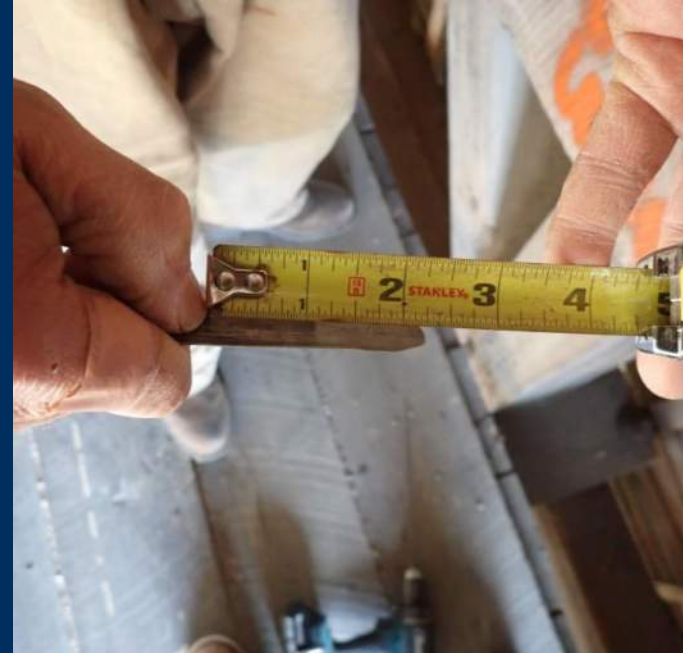
# Measuring Depth of Seasoning Checks

- Southern Pine Timber (SPIB):
  - Select Structural & No. 1 –  $\frac{3}{8}$  thickness  
( $2\frac{1}{4}$ " for 6x14; 3" for 8x10)
  - No. 2 -  $\frac{1}{2}$  thickness (3" for 6x14)
- West Coast Timber (WCLIB):
  - Select Structural & No.1 –  $\frac{1}{4}$  thickness  
( $1\frac{1}{2}$ " for 6x14; 2" for 8x10)

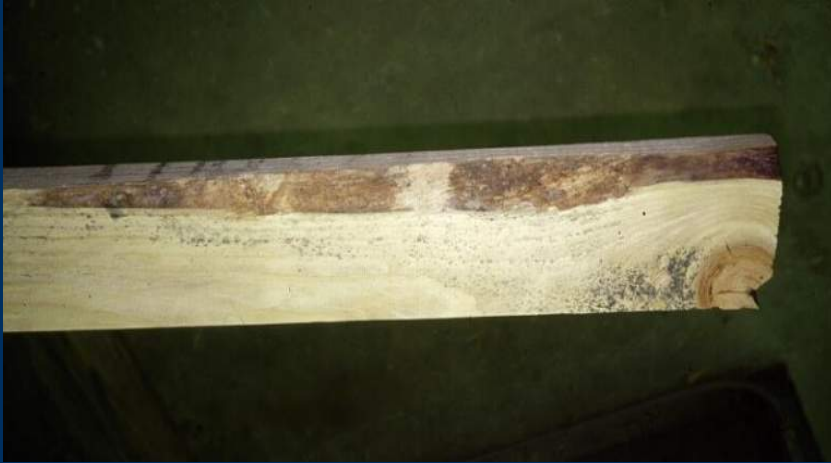
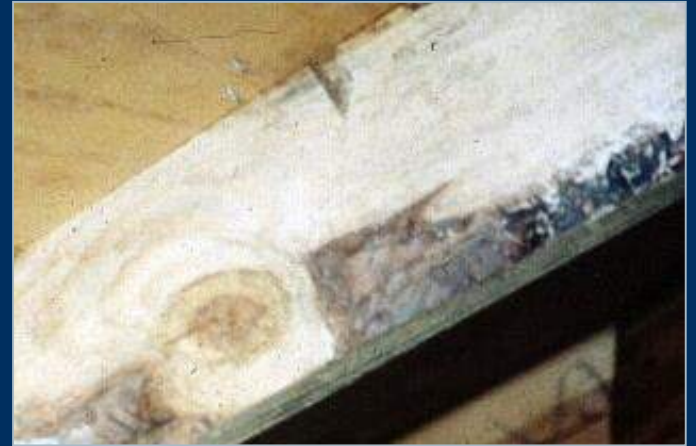
# Wane

*Wane - bark or lack of wood from any cause, except eased edges, on edge or corner of a piece of lumber*

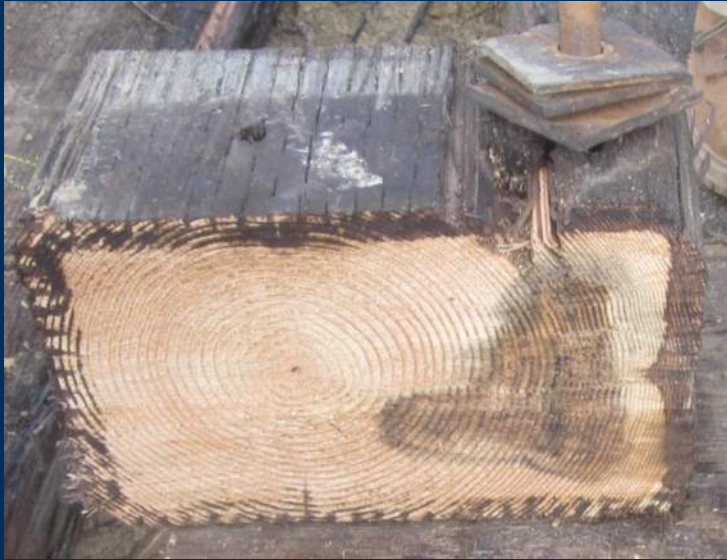
For Douglas Fir, the depth of treatment is equal to the depth of the incising.

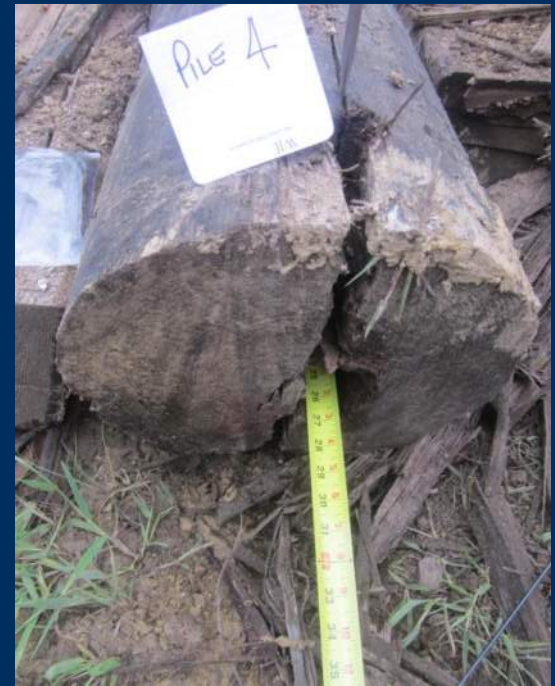
Due to the large cross-section of timber piles, the center of the pile cross-section is typically not treated and subjected to decay.

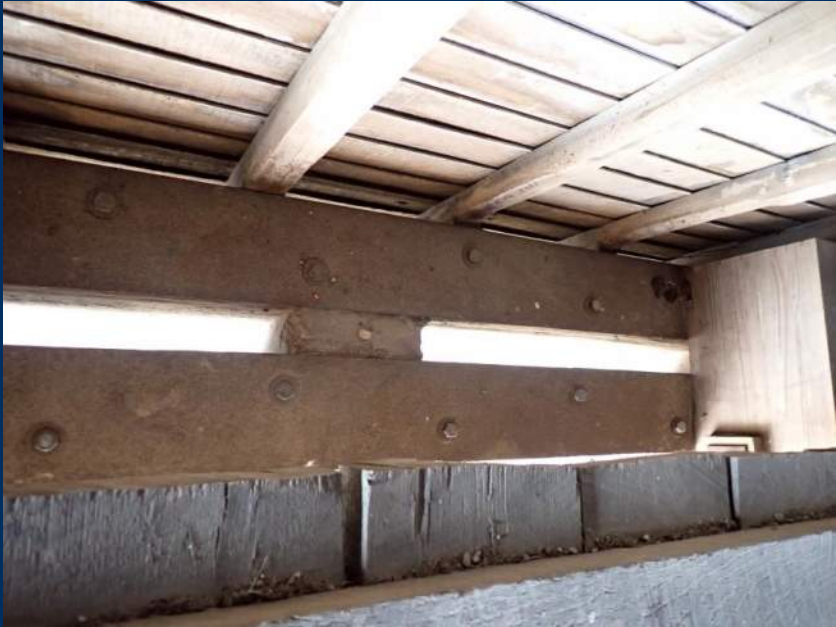
Repairs with Bolted Steel Plates can Trap Moisture

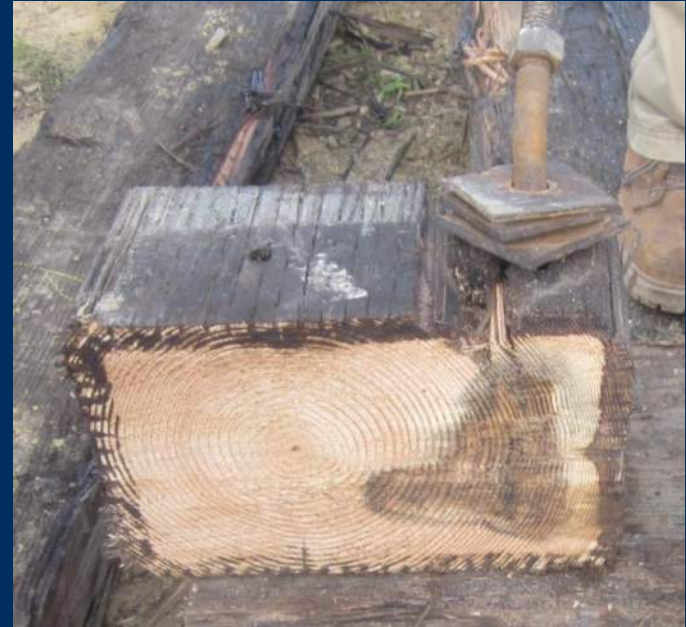
Bolt holes can be a path for Moisture

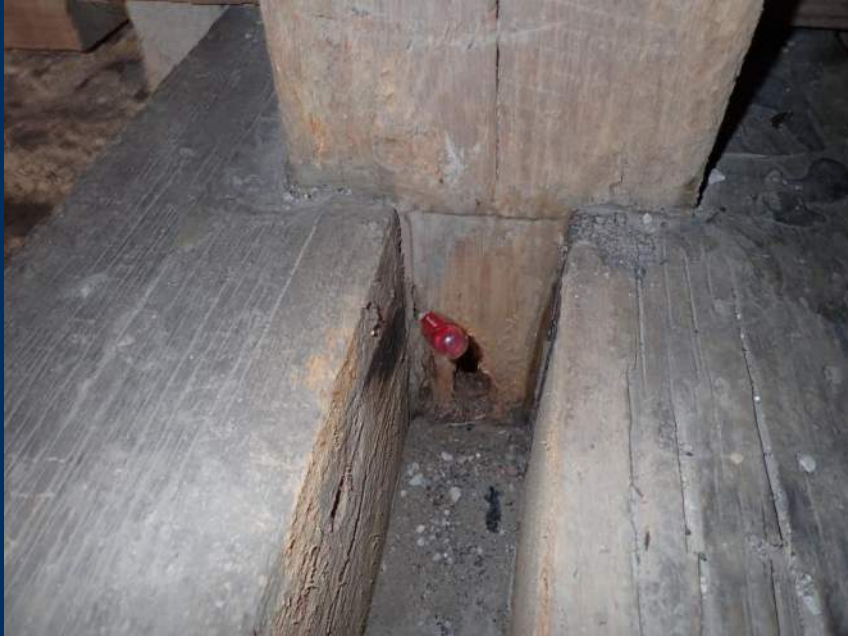
Joint between bottom chord and web member

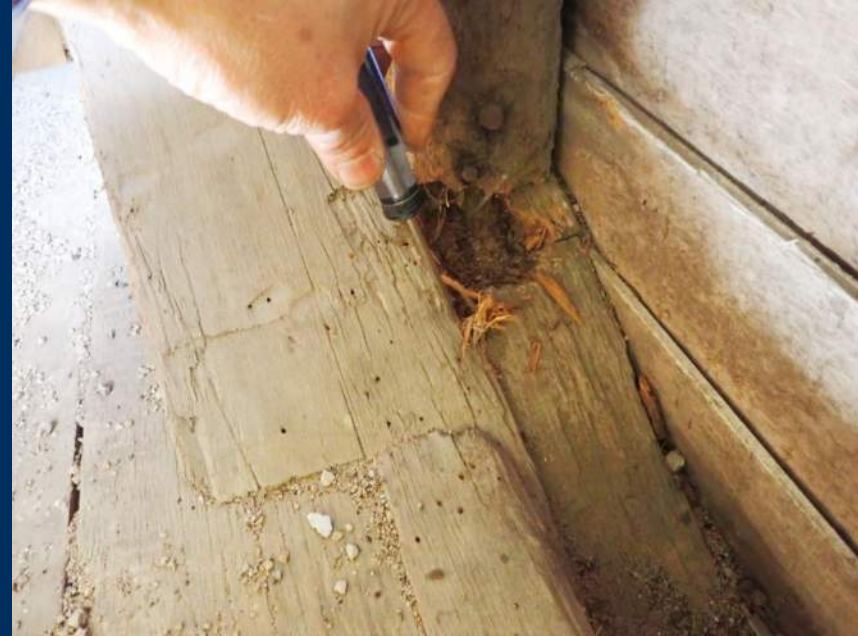
Joint between wall stud and arch

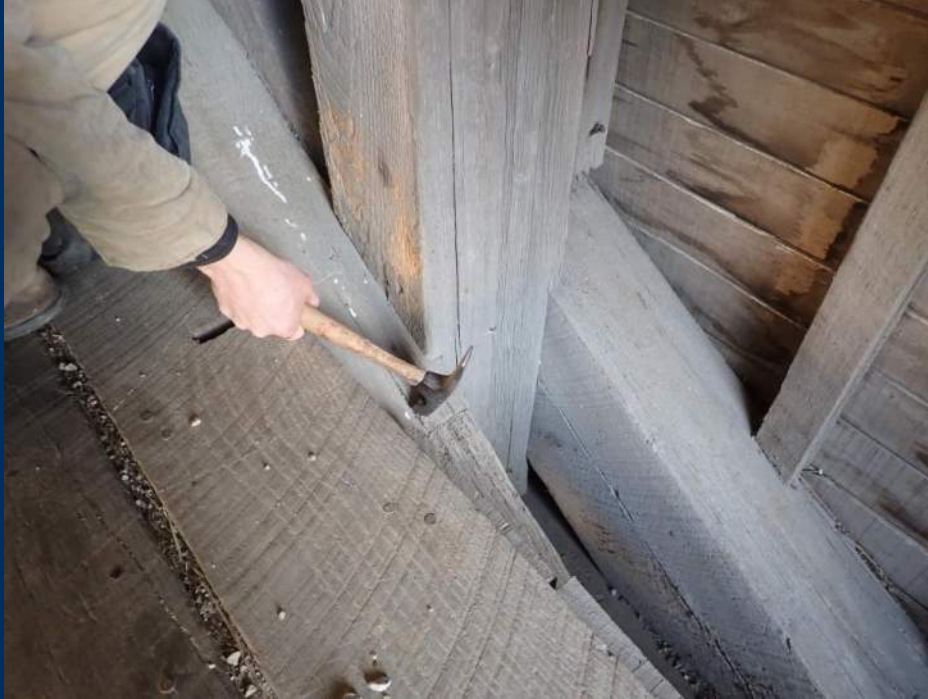
# Decay- Sound Timber Members with a Flat Head Hammer to Identify Hollow Areas

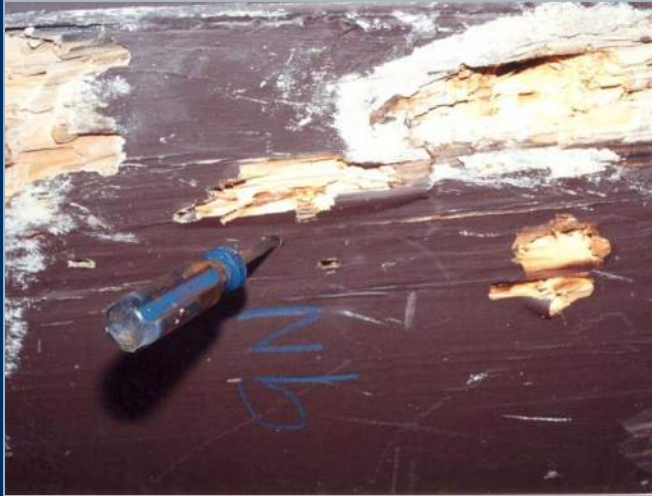
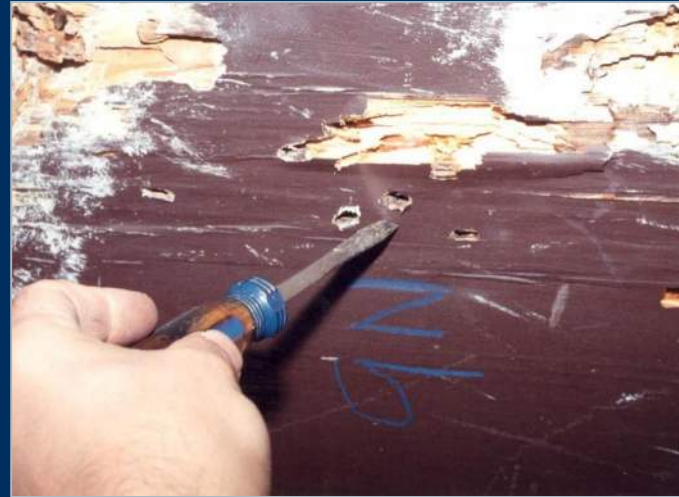
# Decay – Probe Suspected Decay Area to Determine Extent of Decay

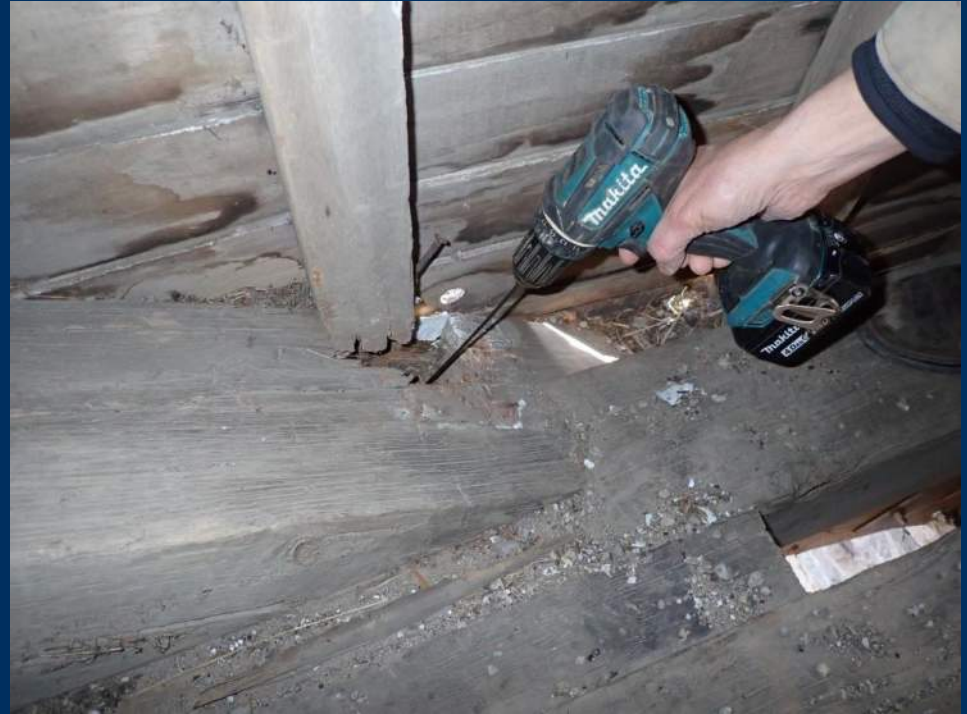
# Decay- Suspect Areas Can be Probed with a Thin Drill Bit

Suspect areas can be probed with long thin drill bits (12 in. long x 1/8 in. diameter) to look for soft pockets of wood

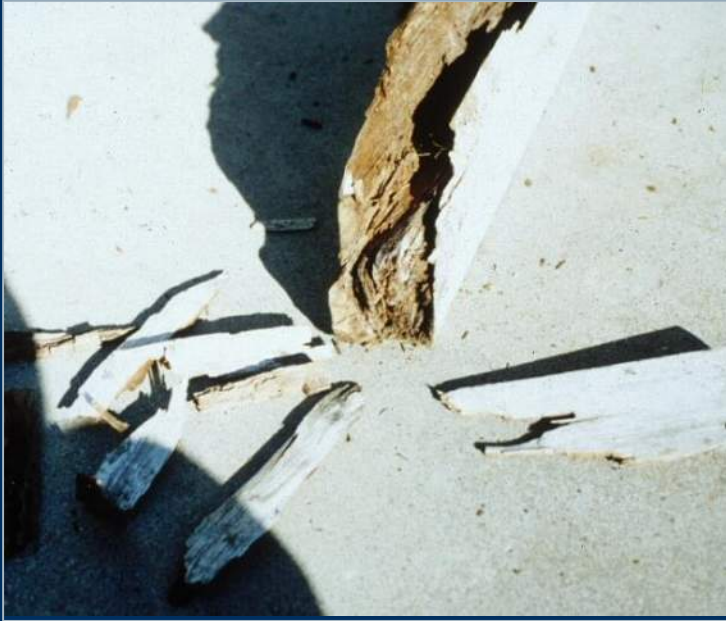
Decay at center of joist leaving thin un-decayed sides (shell)

Water Source at Top of Member

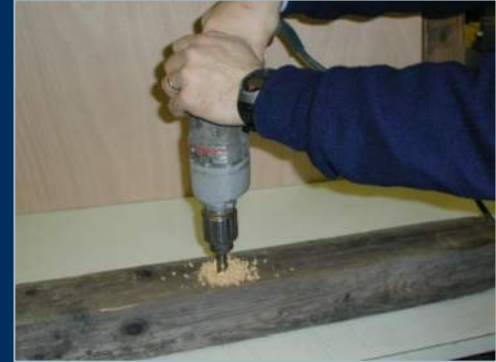
5/8 in. O.D. Single chisel wood core bit (plug cutter) with extensions

3/8 in. dia. Core, with 5/8 in. dia. hole

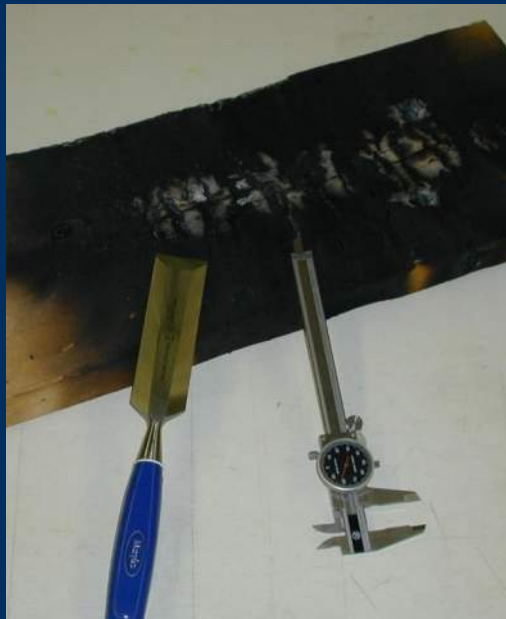
Chisel and Calipers

Scrape char in small square area with a sharp wood chisel down to solid wood

Measure thickness of char with the end of calipers (plunger) at edge of scraped

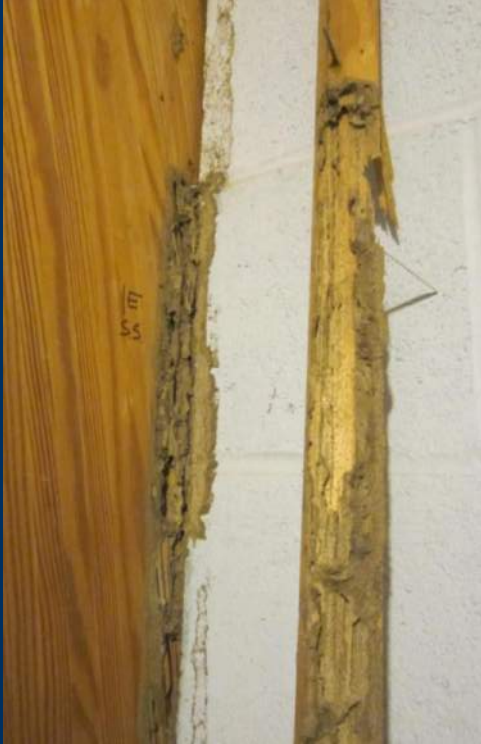
Damage hidden behind molding

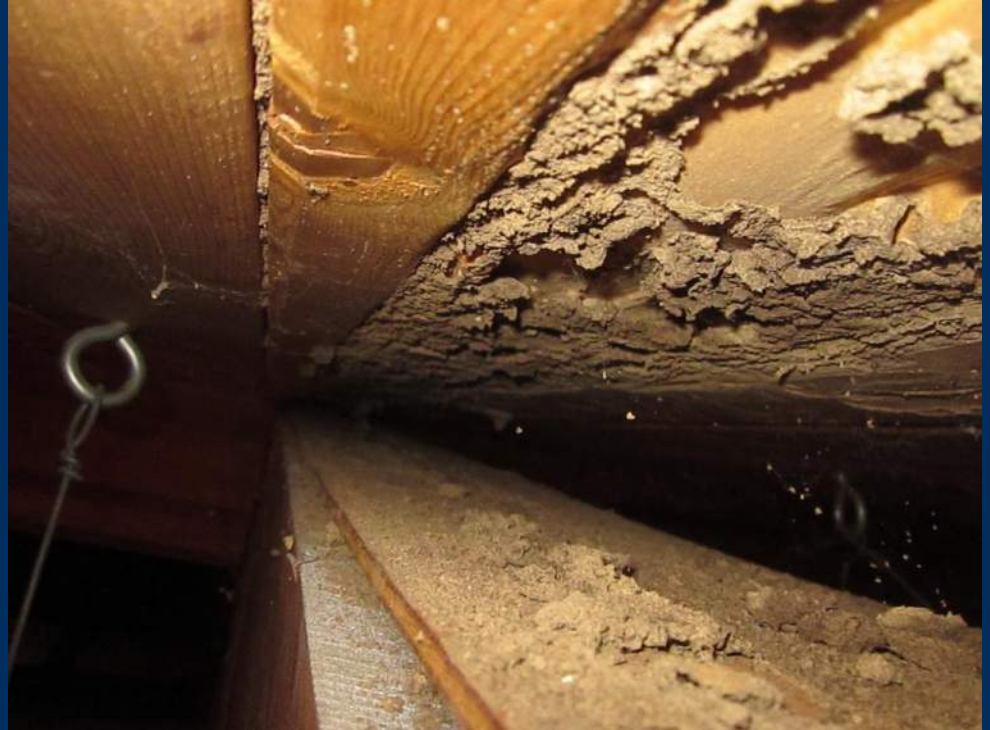
Shelter tubes between boards

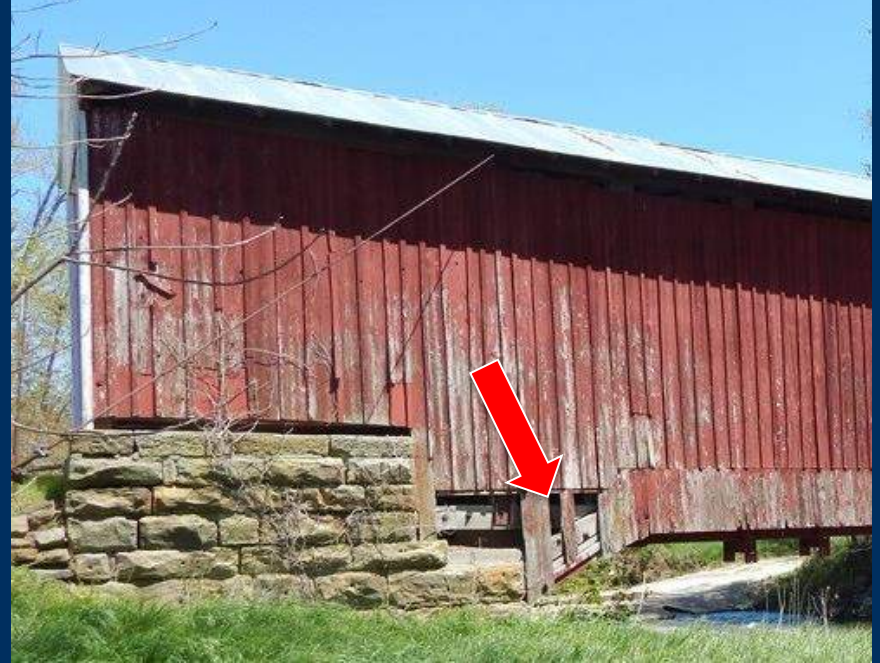
Arch End Covering Intact

Arch End Covering Missing

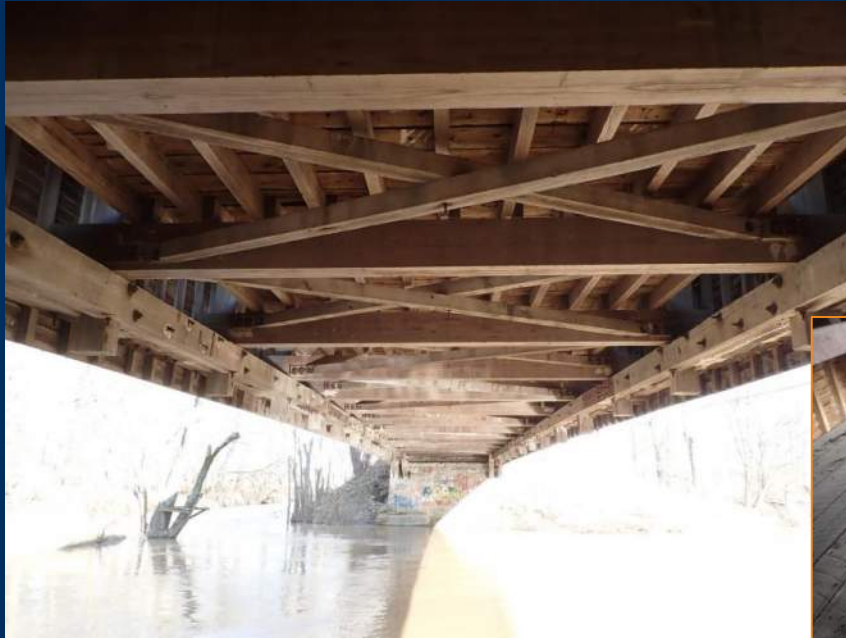
- Only minor deterioration
- Floor system appears to have been replaced since original construction

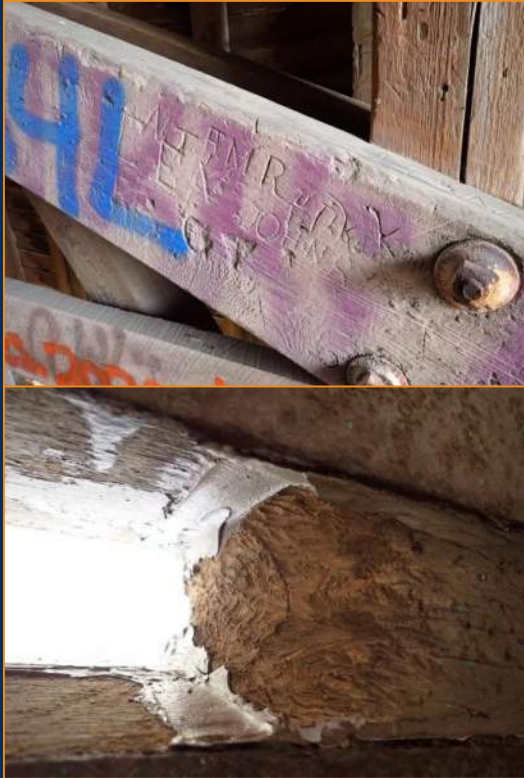
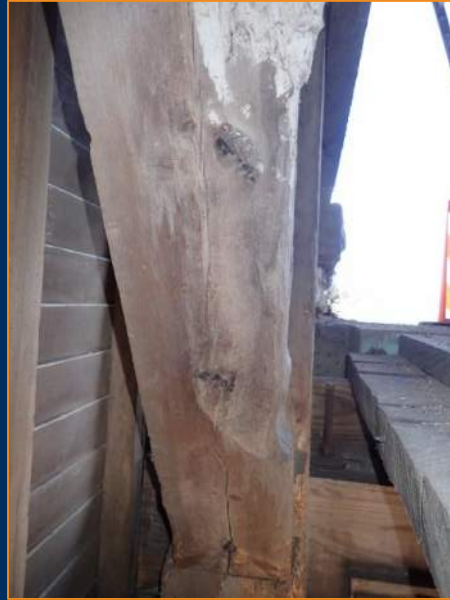
- Minor Wear
- Carving marks
- Nails/ holes from various signs
- Previous probe marks
- Previous fire damage?
- Animal damage?

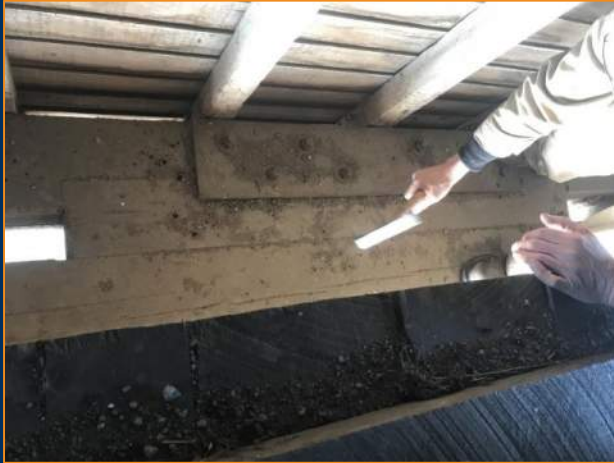
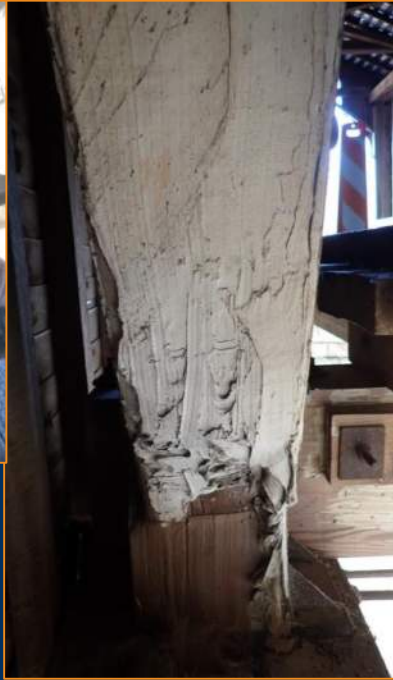
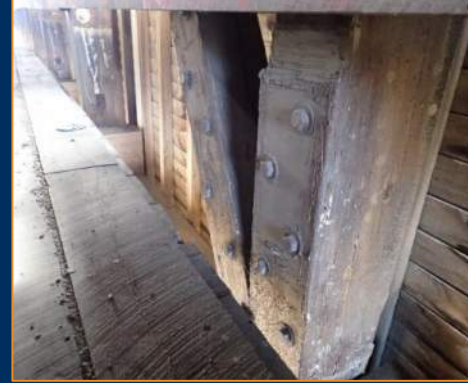
## Bolted Steel Plate and Epoxy Repairs

- Repairs needed for some members, especially at arch bearings. Repairs should consider long term durability of the remaining wood in repaired areas
  - Arch Bearings
  - End Segments of Bottom Chords
- Evaluate suitability for local masonry repairs at abutments, and implement
- Repair holes in siding and roof. Segments need a compatible lapped board system or replacement
- Monitor decay at other repair locations

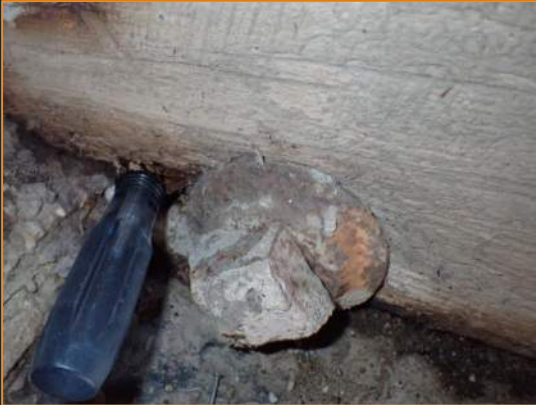
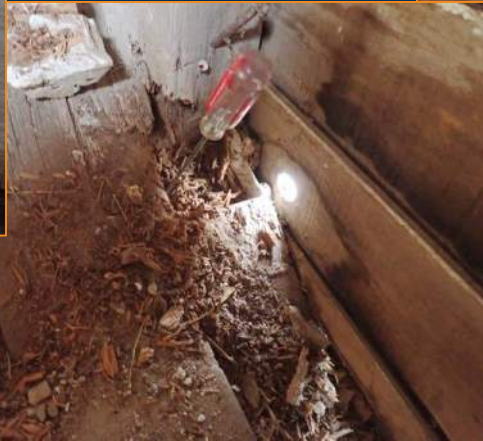
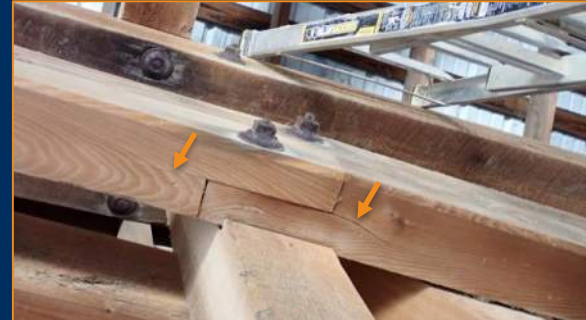
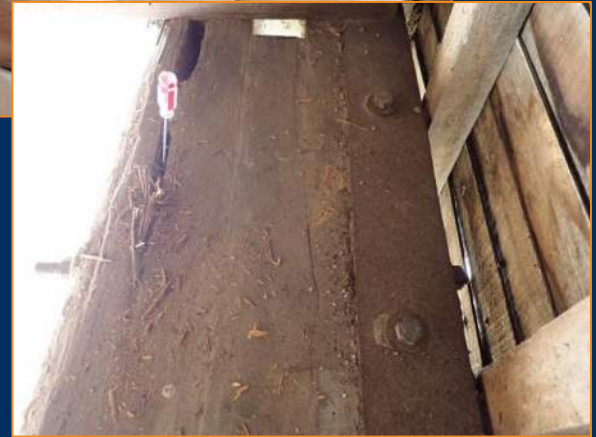
- Minor Distress. Some Severe Decay
- Most Decay at End Panels and Bearings

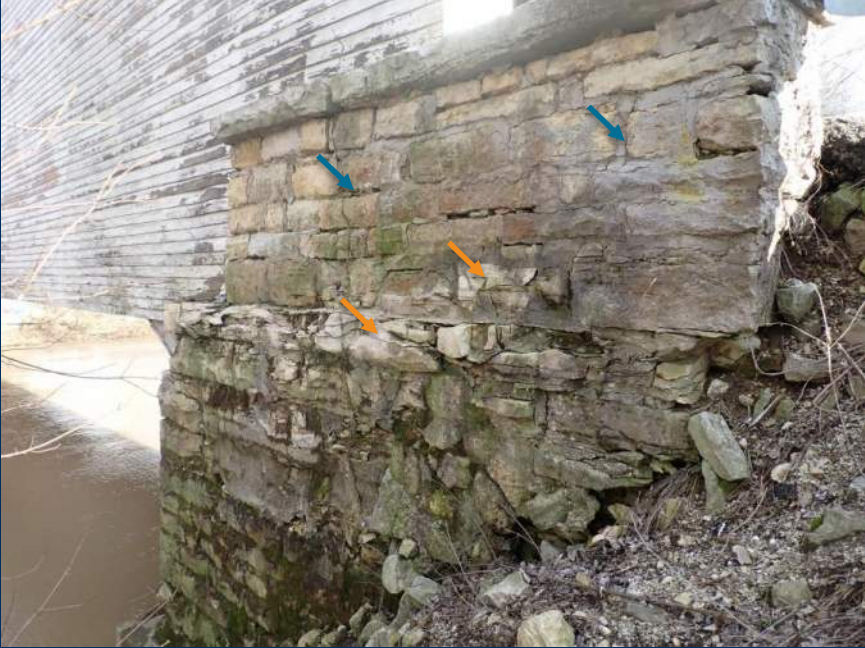
- Delamination type cracking in stone
- Bond line separations in mortar joints
- Some delaminations have progressed to spalls
